Science and Education Administration
In Cooperation With
Food Safety and Quality Service
UNITED STATES DEPARTMENT OF AGRICULTURE

Issued July 1978

METHODS AND FACILITIES FOR GRADING BROILERS AND TURKEYS

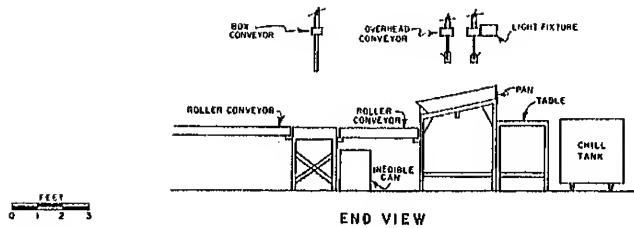
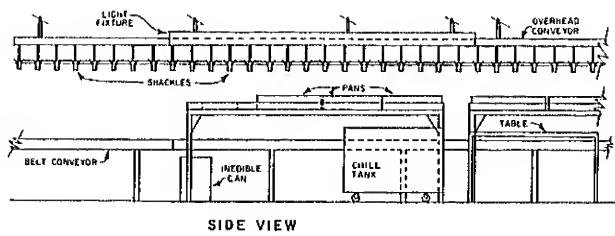
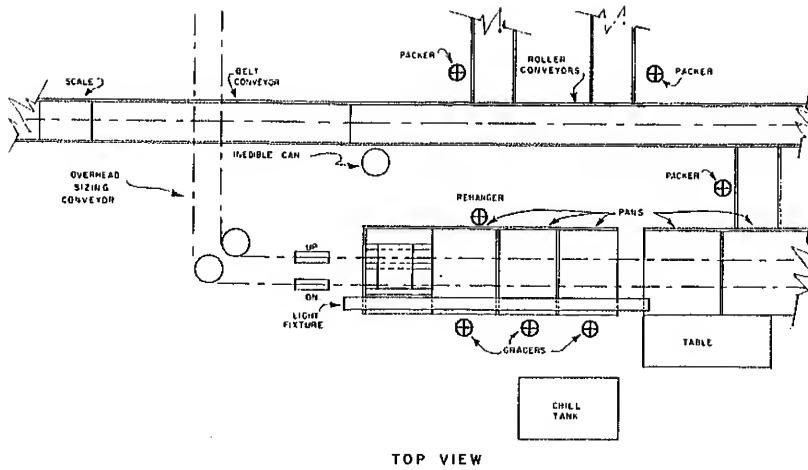
Figure 1.--Layout of broiler grading area in plant A.

Grading is primarily an in-line system in plant A. Figure 1 shows the layout of the grading area and arrangement of the equipment. The birds are suspended from nonrotating sizing shackles by one hock and are transported by a continuous overhead conveyor. It is normally operated at approximately 100 shackles passing the grading station per minute. As the birds pass before the graders, they are graded according to U.S. grade standards. The grade A product is allowed to remain on the conveyor, and undergrades are removed and placed in designated pans. Each shackle has an identification, such as a bird for grading. The identification is readily visible to avoid needless eye movement to the top of the shackle, since this can detract from the grading function.

- (1) Space is adequate around the graders.
- (2) Birds are presented at such a height that the graders can easily see the entire carcass.
- (3) The layout necessitates only limited separation of undergrade birds. Once the graders have decided that a bird is an undergrade, they do not have to select from several choices in disposing of it.
- (4) Each grader is required to grade approximately the same number of birds because of the identified shackles and the uniform pacing by the overhead conveyor.
- (5) Adequate adjacent space and facilities are provided for reconditioning birds to meet grading requirements.
- (6) Lights extend the full length of the grading area.
- (7) The hook of the shackle is turned toward the graders and thus does not obscure their vision of hock bruises and discolorations.
- (8) The sloped pans keep the undergrade birds away from the graders.

- (1) The top of the pans restricts the graders' accessibility to the birds; they have to reach over the pans to get the birds.
- (2) The light fixture is too far in front of the graders so that the light shines in their eyes.
- (3) The shorter employees require foot stands.

In plant A, the top of the pans for undergrade birds is 48-1/2 inches and the overhead conveyor shackles are 60 inches above the floor at the grading stations and at the opposite side of the pans where the undergrade birds are rehung on the overhead conveyor (cut-up line).

At the grading stations, the top of pans restricts the graders' accessibility to turn the birds around and to lift the undergrades from shackles since the top is 48-1/2 inches high. However, the shorter graders normally use a foot stand, which is usually 8 inches or less in height for safety reasons. Thus, when the short person is raised to a working height of 45 inches, the top of the pans is 3-1/2 inches too high. The pan height is more convenient for men, but even for them the pans are too high.

To alleviate the height problem for the short graders and to make the birds more accessible to others, the overhead conveyor could be raised 6 to 10 inches and a platform with a guardrail around it could be installed in the grading area. This platform should be wide and sturdy to insure safety and it could have adjustable legs so it could be raised or lowered to satisfy the graders' needs. Raising the overhead conveyor by 6 to 10 inches would bring the breast of the birds, suspended from the shackles, to the approximate eye level of graders. For women this is 58 inches from the floor (4).

Since the light fixture is too close horizontally to the overhead conveyor so that it shines into the eyes of the graders, it should be moved away from the overhead conveyor and raised to 6 feet 8 inches above the floor.

Another way to improve the grading operation is to provide more space between graders. In plant A, the pans for undergrade products are 30-1/2 inches apart and tend to limit the workspace for each grader to that width. With the shackles 6 inches on center and the overhead conveyor traveling at 100 shackles per minute past a given point, the grader has only 3 seconds per bird to perform his task when confined to 2-1/2 feet, whereas when the grader has 3 feet of space, he will have 3-3/5 seconds. Therefore, at least 3 feet of space should be provided for each grader. This can be accomplished by moving the table for wing tags and separating the three pans for undergrade birds to 6 inches or more or by using wider pans.

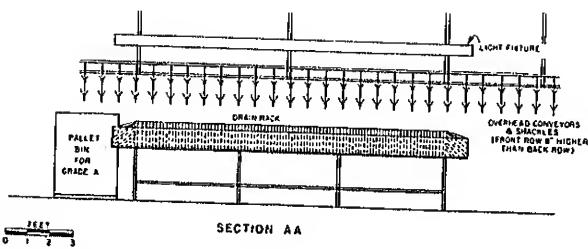
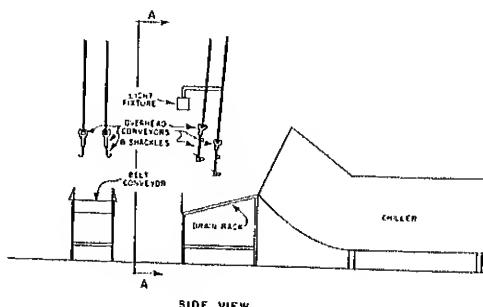
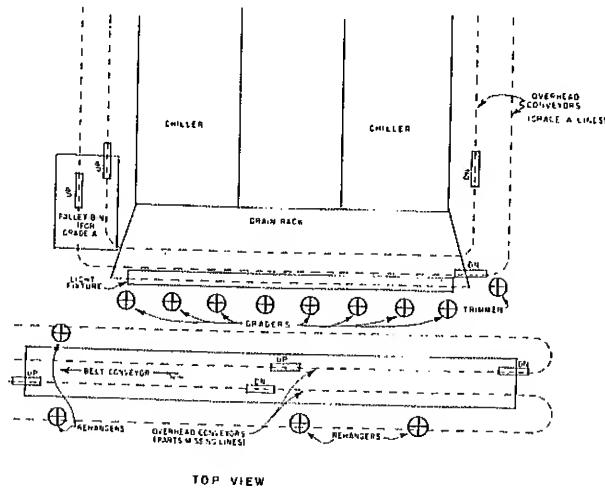
Figure 2.--Layout of broiler sorting area in plant B.

Figure 2 shows the layout of the sorting area, located at the exit end of the chilling machines, and figure 3 the layout of the grading area, located at a point just prior to the giblet stuffing operation.

- (1) The grader has difficulty seeing the back of the birds, because they are suspended from the overhead conveyor by nonrotating shackles.
- (2) Undergrade birds are not easy to remove from the shackles.
- (3) One of the grading positions has inadequate space for grading and not enough room adjacent to it for reconditioning the product.
- (4) Each grading position is only 24 inches wide.
- (5) Since the floor is not well drained at the grading area, the graders stand on platforms, where their eye level is at about the height of the shackle rather than the bird.
- (6) The grading area is not well lighted.
- (7) Birds accumulate to an excessive depth in the drain rack at the sorting area and contribute to the inefficiency of sorting and hanging the birds and increasing the probability of some of them being left in the rack for extensive periods.

(8) The drain rack is approximately 17-1/2 feet long, with less than 2 feet of workspace for each of the eight graders and one trimmer.

The sorting area is too congested. One way to alleviate this problem is to provide more drain rack space or frontage. This could be accomplished by moving the chillers farther apart and adding more rack in that area; however, moving the chillers probably would be costly, both in moving expense and wasted floorspace between the chillers. Another way to get more rack space would be to extend the rack at either end using deflectors or belt conveyors to move the birds out the ends. Complete separation of the two hanging areas, with separate slower moving overhead conveyors, would probably facilitate the highest degree of efficiency; however, this alteration also would be costly. In many other plants the sorting and hanging are performed from a belt conveyor moving in the same direction as the overhead conveyor. Usually the birds slide onto the moving belt conveyor as they come out of the chiller, moving along the conveyor until they are on the overhead conveyor shackles or dropping into a chill tank at the end of the belt. This might be more efficient than the present system.

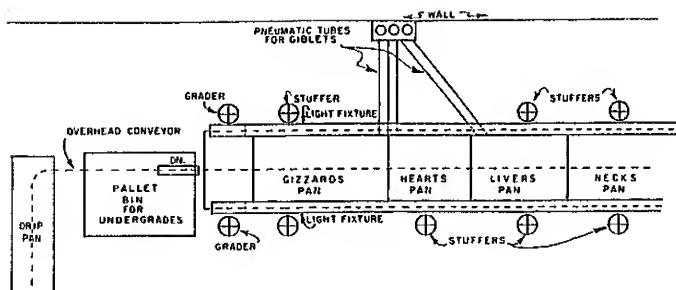
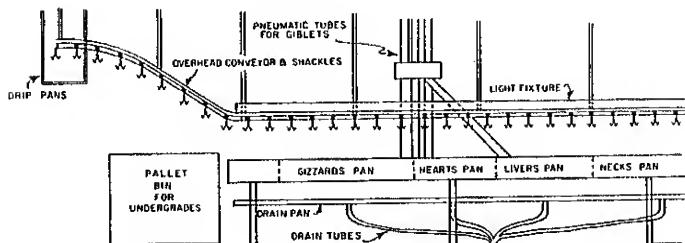
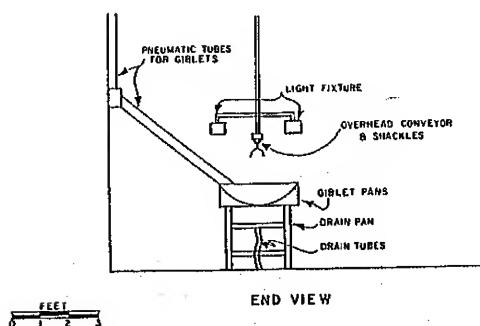
Figure 3.--Layout of broiler grading area in plant B.

Grading is performed on an overhead conveyor by two authorized graders (fig. 6). Undergrade birds removed from the conveyor at the point just before the giblet stuffing operation are dropped into a pallet bin, where, after accumulation, they are transported to another area of the plant and hung on an overhead conveyor for the cut-up operation.

The grading operation in plant B could be improved by increasing the width of the grading stations and improving the floor drainage in the area or raising the height of the shackles at the grading stations. The taller graders have difficulty seeing the lower half of the birds, and if the floor were well drained, these graders could stand on the floor rather than on the platforms. Also, fluorescent or other approved lamps should be installed on each side of the grading line (fig. 3) at a height of 6 feet 8 inches and about 3 feet from the overhead conveyor, and they should provide at least 50 foot-candles of light (3).

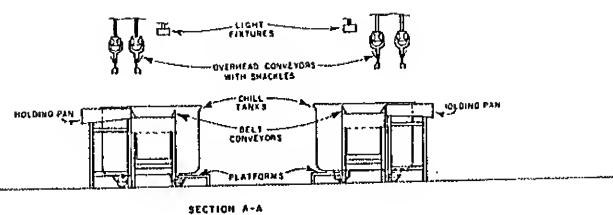
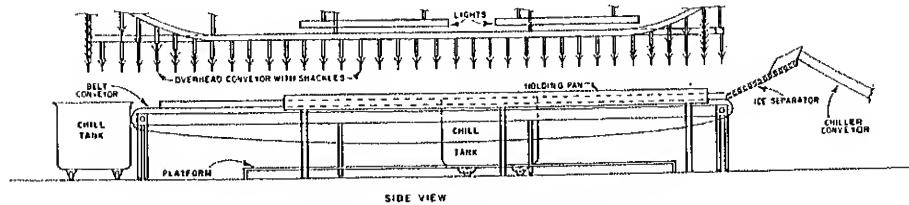
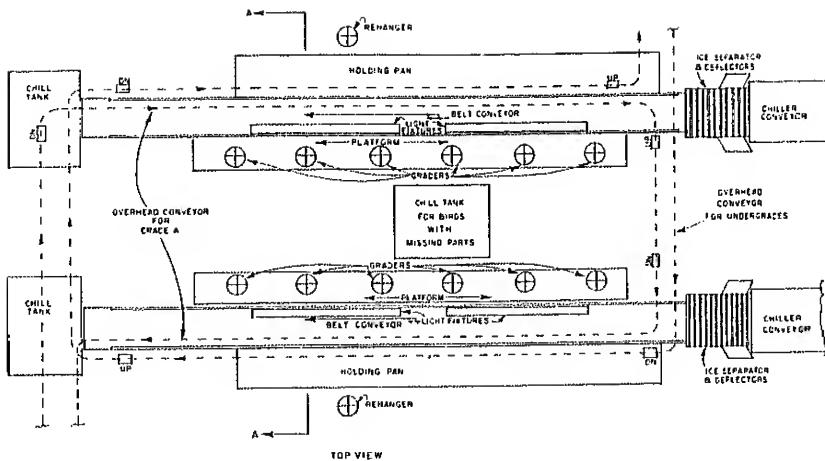
Figure 7.--Layout of broiler grading area in plant C.

As the birds pass along the two 25-foot belt conveyors (fig. 7), each one is lifted from the belt and graded. Those meeting the grade A standards are hung by a hook in shackles on an overhead conveyor, which takes them to the sizer located in another area of the plant. The undergrade birds are tossed into stainless steel holding pans, 17 feet 8 inches long and 2 feet wide, alongside the belt conveyors. From the holding pans, the birds are rehung on shackles of the overhead conveyor for undergrades. Both overhead conveyors serve as drip lines. Giblets are stuffed in the grade A birds before sizing.

- (1) Because the birds are mingled together on the belt conveyors, the production rates of the first two or three graders on the line are restricted since they have to separate the birds before grading them.

(2) Likewise, some of the graders near the end of the belt conveyors have to wait for empty shackles to hang their grade A birds, because many of the shackles have been filled by other graders.

(3) The grading function is not equally distributed among the graders; the first graders have to grade more birds than those at the opposite end of the grading belts.

(4) The grading operation occupies an excessive amount of floorspace relative to grading operations in other plants.

(5) Accuracy and efficiency are less than optimum. Fourteen persons plus support personnel are involved in sorting, grading, and rehanging; some are working close to their maximum capability, whereas others are not.

The belt conveyors from which the grading is performed frequently become overcrowded, and the selection and handling of birds in the grading process become more difficult. Grading would probably improve if the plant processing volume were reduced. A 10-percent reduction might facilitate a 20-percent increase in grading efficiency. The plant is operating above its design capacity.

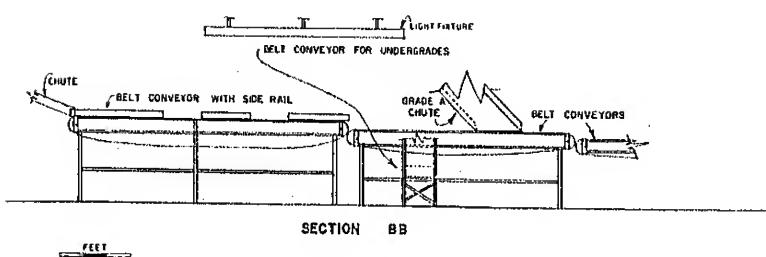
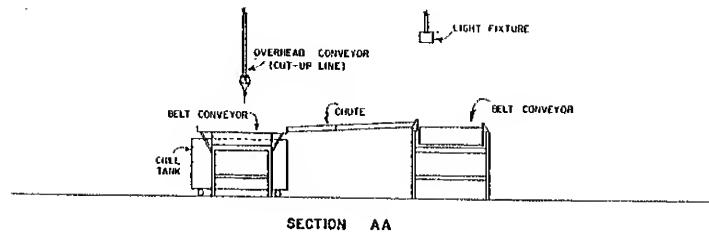
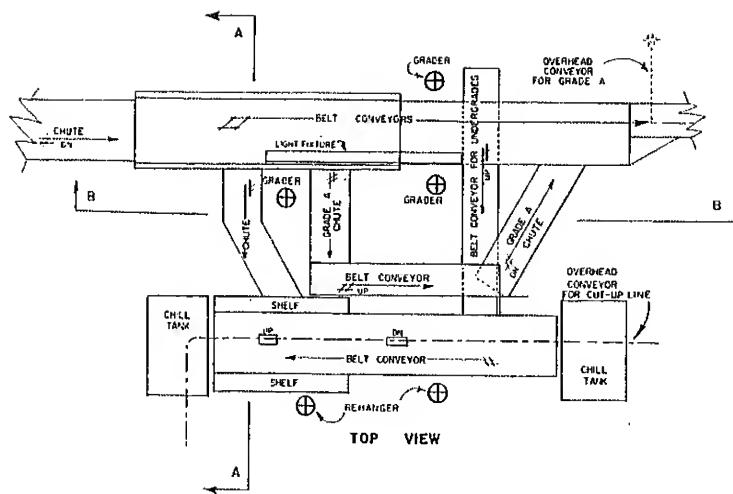
Figure 8.--Layout of turkey grading area in plant D.

(1) The grading area has inadequate space for maneuvering from front to back of the workplace, and accessibility is restrictive, particularly for two of the grading positions.

(5) Safety and noise levels at the grading area could be a problem. A belt conveyor operating about 5 to 6 feet above the floor and behind one of the graders could be a safety hazard. The grader has to go under a chute while stepping over another belt conveyor in order to get to and from the grading position. This is inconvenient and unsafe. Noise at the grading area is relatively high because numerous machines are operating close to the graders.

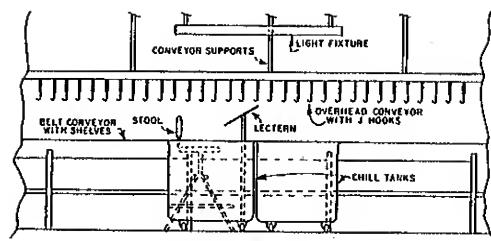
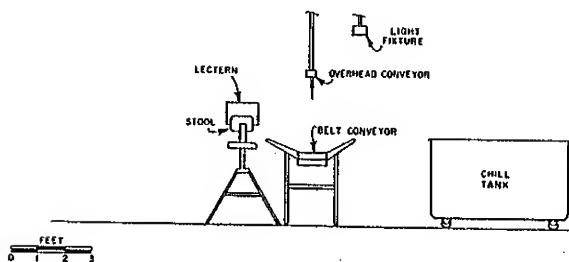
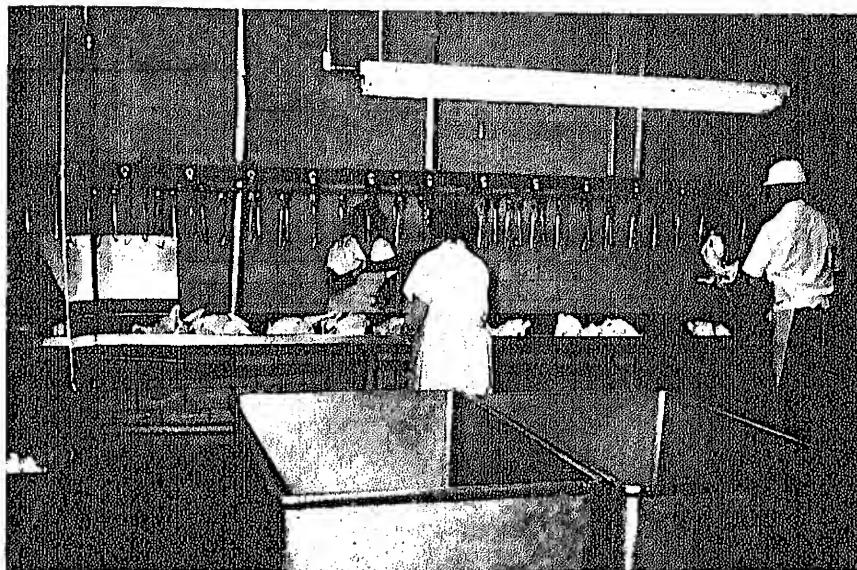
Figure 13.--Layout of turkey grading area in plant F.

The layout of the grading area is shown in figure 13. Plant F has "producer grading," with the grade data being recorded. This is available to all qualifying plants on request. As the birds are transported by the belt conveyor (fig. 14), the grader holds each one by a wing and observes the condition of the breast side. If the standards for grade A are met, the bird is turned on end and the back side is checked. Grade A birds are left on the belt, continuing to the next work station, where they are hung in shackles attached to the overhead conveyor. Giblets are stuffed in the birds after they leave the grading area. Undergrade birds are deposited in chill tanks (fig. 14) behind the grader. Space around the grading area is ample, as shown in figure 14, and the noise level, which is relatively low at approximately 80-85 decibels of the A scale, contributes to an effective work station.

(2) J hooks moving past the grading area at 4 feet 8 inches above the floor could be hazardous because they are close to eye level.
